PROPERTY INSPECTION REPORT

Site Address
Site City PA

INSPECTION PERFORMED BY:
Eric Kraklio

RE: Site Address
Site City, PA
Report #SAMPLE

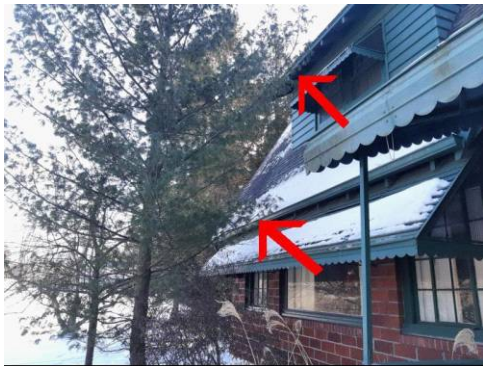
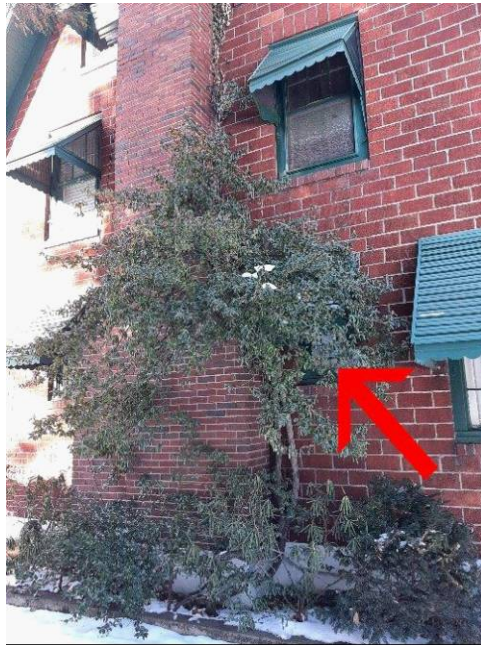
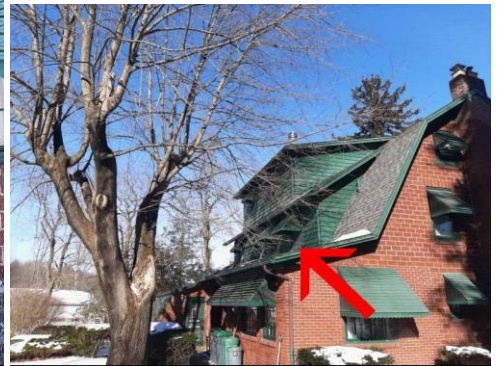
Observed at various areas: Vegetation is touching and/or growing to close to the structure, damage to the house is possible with further growth, trimming away from structure is advised.

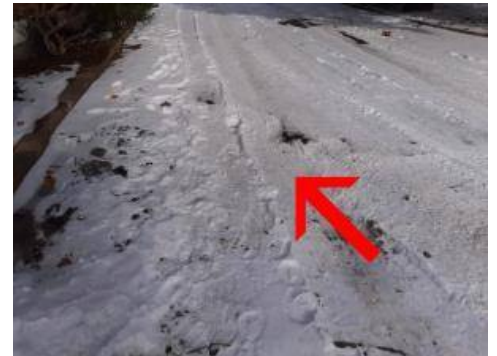
Observed at the left side: Limited viewing of this area because of the snow cover suggests there is movement or a pothole in this area. Once snow has melted further evaluation may be necessary. Monitoring the situation is advised. Appropriate professionals should further evaluate if there are deficiencies suspected or confirmed in the future.

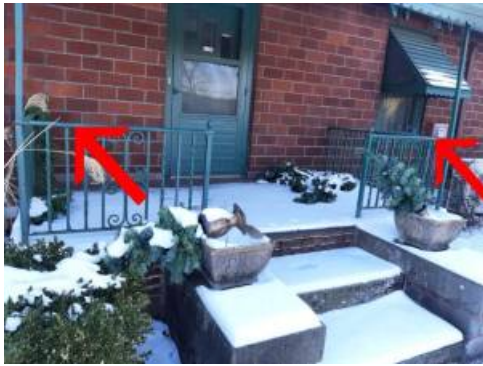
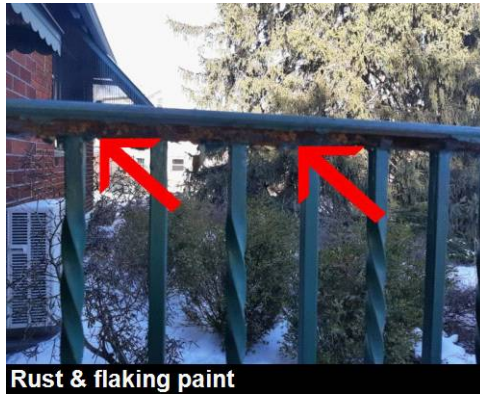
Observed at the front side stoop: When comparing to today's standards the guardrails would be to low for current safety standards. This is a typical finding of an older home. Some rust and flaking paint is noted on a small portion of the guardrail. Some preventative maintenance may be necessary to extend the life of this rail. Monitoring the situation or further evaluation with remedy as necessary by qualified, competent tradesperson.

Rust & flaking paint

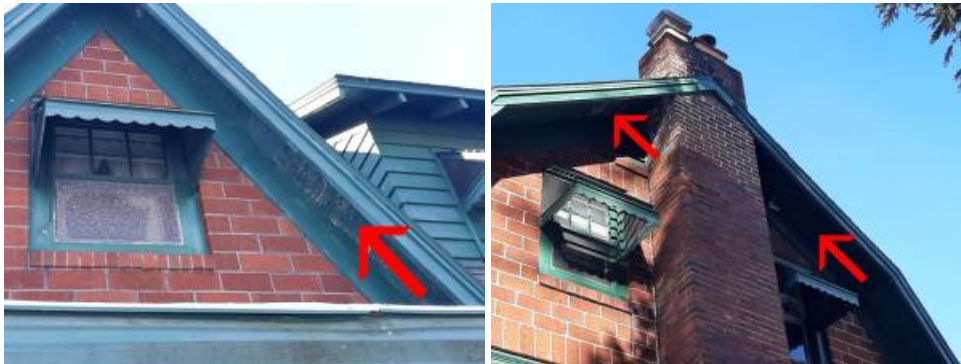
- Observed at various areas: Exterior trim is weathered. Maintenance is needed to preserve the trim and prevent deterioration. A fresh coat of paint is needed mainly in the weathered areas only. A professional painter is recommended to perform maintenance as needed.

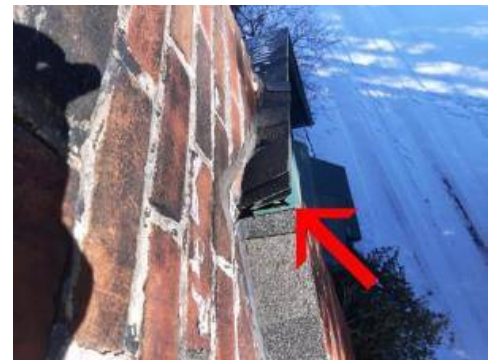
- SF
 - AC
 - FR
 - UP
 - GO
- Observed on the left side of the roof: One shingle is damaged. This area is located at the peak of the roof next to the chimney. Minor repairs are anticipated to bring into acceptable condition. This remedy or repair can easily be accomplished by a handy person.

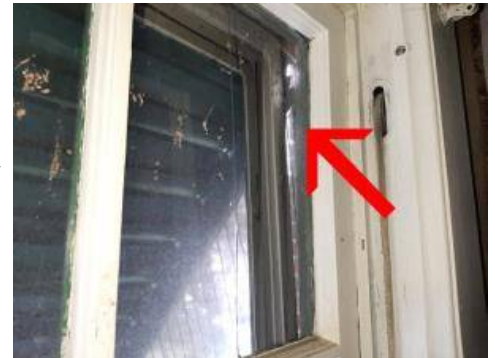
- Observed at the Master bedroom window: Storm window framing is loose on the exterior of the home. Re-attaching the frame is advised. Minor repairs are anticipated to bring into acceptable condition. This remedy or repair can easily be accomplished by a handy person.

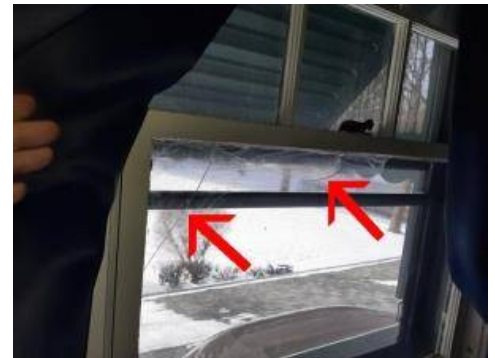
- Observed at the right rear bedroom: Glass is cracked. Recommend further evaluation with remedy as necessary by qualified, competent tradesperson.

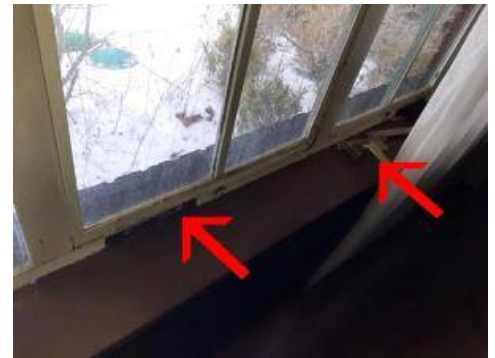
- Observed in the dining room: Hardware is damaged and missing. A competent repair person with the proper skills can accomplish the needed remedies, corrections, or repairs.

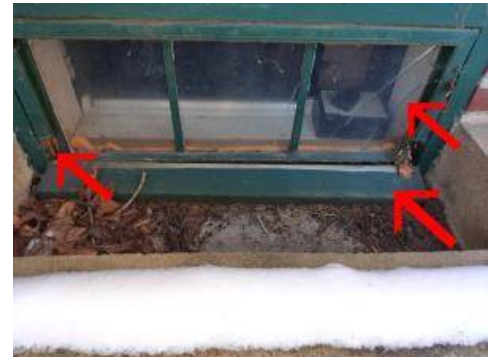
- Observed in the basement: Window frame is damaged. Glass is cracked. A competent repair person with the proper skills can accomplish the needed remedies, corrections, or repairs.

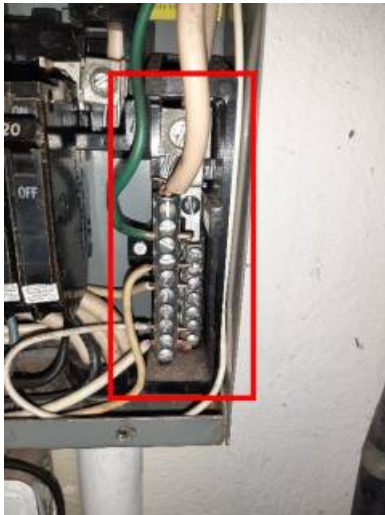
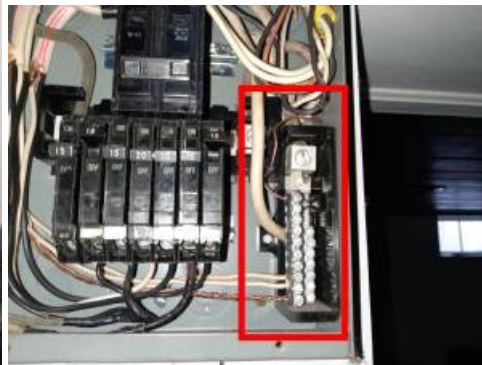
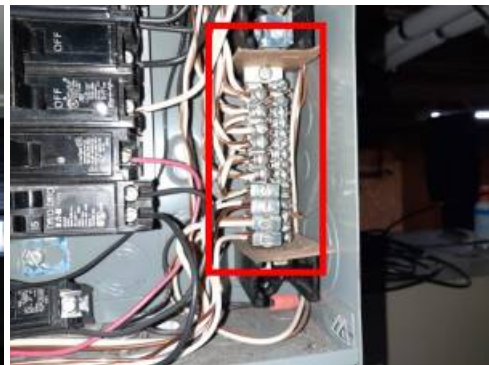
Observed at the # 1, # 2, and # 4 sub panel: Grounding conductors are connected to the neutral buss bar and is an incorrect installation for a sub panel. Grounding conductors are supposed to be connected to the grounded buss bar. A qualified, competent, licensed electrician is recommended to service as necessary.

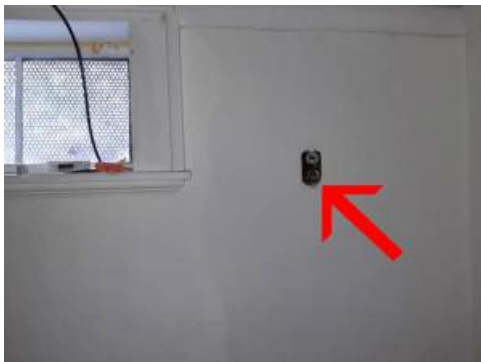
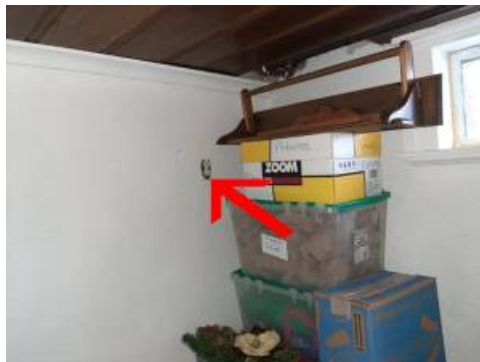
Observed in the basement right side room: There are a couple outlets in this room which are installed in the concrete wall. With the testing device these outlets are not showing power but has the potential if power is restored at a remote location (switch or breaker). These outlets are very corroded which has the potential if activated to cause an arc. Removal, replace, and/or ensure that these outlets are permanently powered down is recommended for safety of the occupants. Recommend further evaluation and remedy as necessary by qualified, competent, licensed electrician.

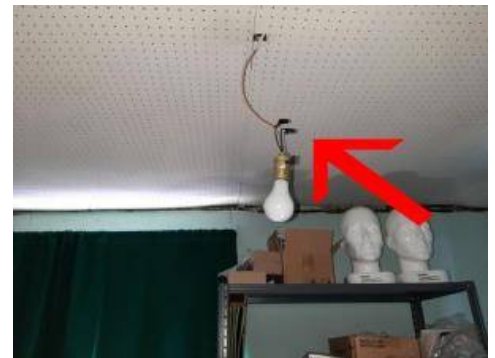
Observed in the garage: Light fixture is not installed at the mounting junction box and the wires are exposed. A qualified, competent, licensed electrician is recommended to service as necessary.

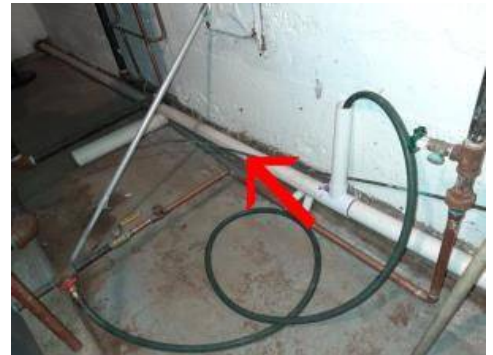
Observed at laundry room drain system: It appears a Grey water system is installed for the washer. Grey water systems are typically found at some rural properties. Grey water from interior plumbing fixtures (waste water) appears to be draining onto the exterior grounds. The exact location of the termination point is unknown. Grey water lines are no longer recommended by the EPA. Plumbing the laundry drain to the private septic system is recommended.

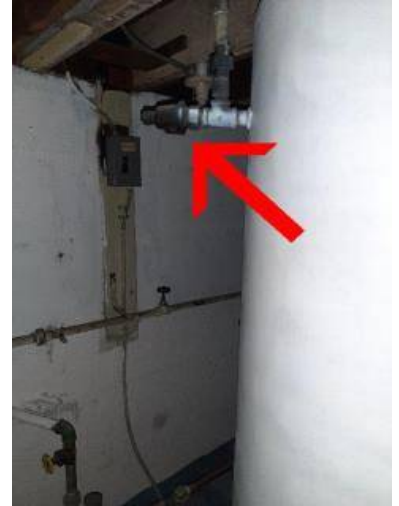
- Termination of the pipe is too high. Recommend terminating the pipe between 6 to 12 inches above the grade level or floor for effective and safe dispersal of water and steam in the event of an overheat situation.

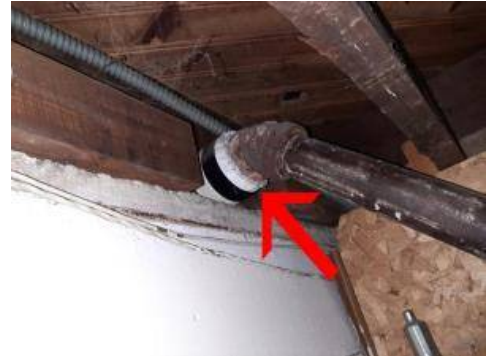
Observed in the basement closet: A short section of the distribution plumbing suspected asbestos material. Testing suspected material by a certified environmental professional and/or laboratory must be performed to confirm if the material is in fact asbestos. Confirming and/or testing of asbestos is beyond the scope of this inspection.

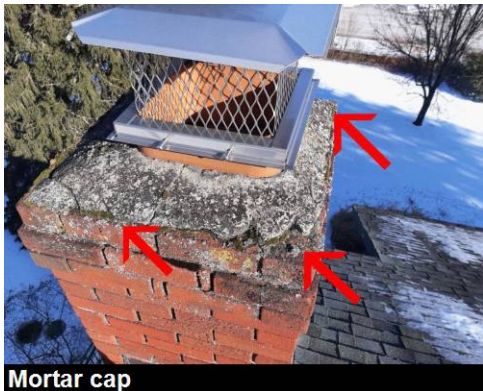
- -
 -
 -
 -
- Observed at the chimney: Mortar cap is showing some deterioration. This area is considered normal maintenance. Mortar cap is design to prevent water from entering the masonry brick which over time has the potential to damage the chimney. Keeping the mortar cap in good condition is recommended and will need periodic maintenance. Minor repairs are anticipated to bring into acceptable condition. This remedy or repair can easily be accomplished by a handy person. Flashing at the chimney was not embedded into the brick which is a better building practice. Caulking the at the top of the flashing will be a periodic maintenance issue as the caulking will shrink and crack over time. Monitoring the situation is advised. Appropriate professionals should further evaluate if there are deficiencies suspected or confirmed in the future.

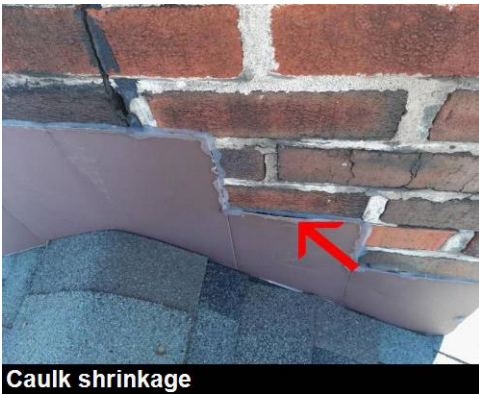
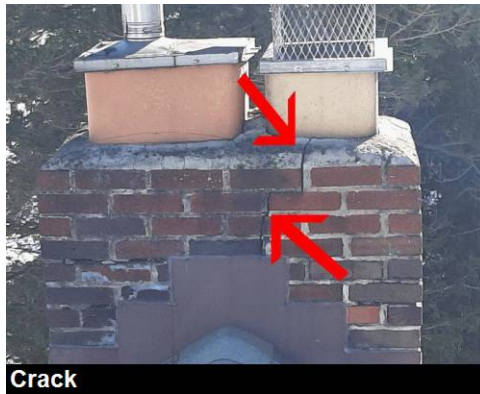
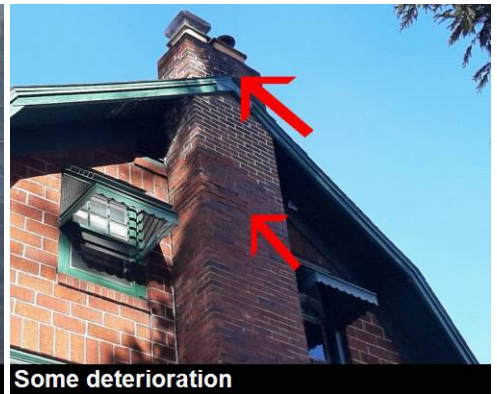
Observed at the # 1 and # 2 stove: Chimney is showing some deterioration. Re-pointing some of the mortar joints is suggested. Mortar cap is cracked. Patching cracks in the chimney cap will help to prevent water damage to the masonry components. A crack is noted on the one side of the chimney which will allow water to enter the masonry. Flashing is not embedded in the brick and the caulking is shrinking allowing a gap. Recommend further evaluation with remedy as necessary by qualified, competent tradesperson.

Caulk shrinkage

Crack

Some deterioration

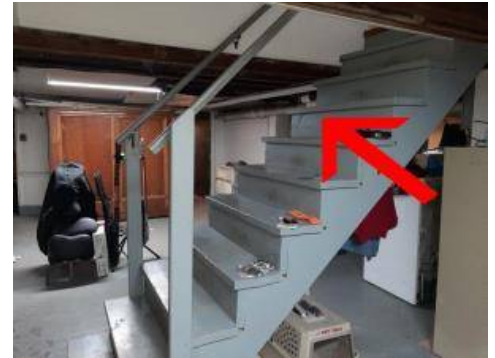
-
-
-
-
- Observed at the basement. A guardrail is not installed at a hazardous area. Any area that has over a 30" drop off should have a guardrail installed for safety.

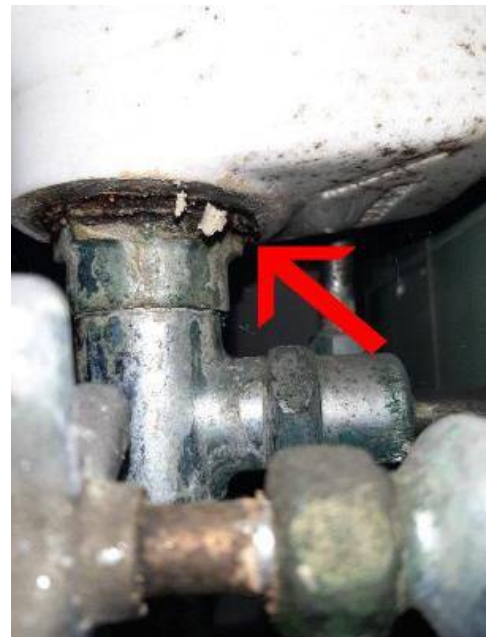
- Observed in the # 5 bathroom(s): Drain line is leaking. A competent repair person with the proper skills can accomplish the needed remedies, corrections, or repairs.

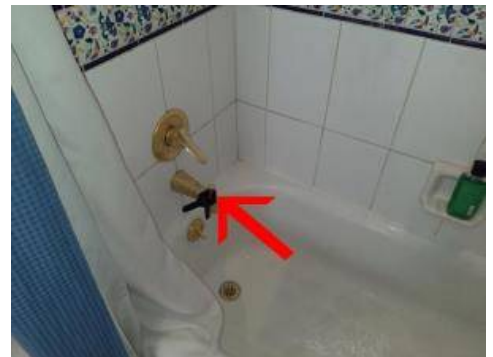
- Observed in the # 1 bathroom: Functional water flow is marginal. Shower diverter mechanism is damaged and not operating correctly. A licensed plumber is recommended to service as necessary.

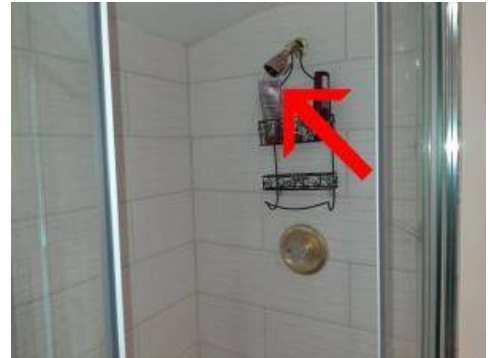
- -
 -
 -
 -
- Observed in the # 3 bathroom(s): Functional water flow is low. A licensed plumber is recommended to service as necessary.

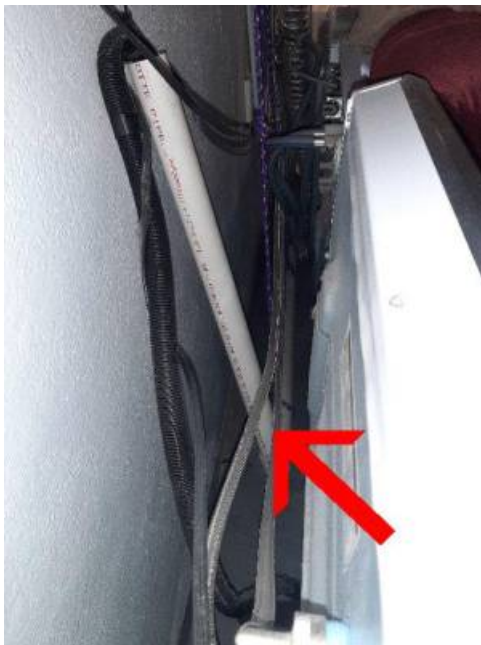
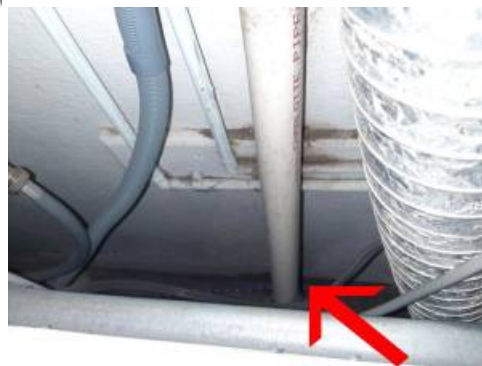
Observed at the main house laundry room. Washer drain trap is not observed, suspect that an improper drain piping configuration installed. A competent repair person with the proper skills can accomplish the needed remedies, corrections, or repairs.
