PROPERTY INSPECTION REPORT

Site Address
Site City PA

INSPECTION PERFORMED BY:
Eric Kraklio

RE: Site Address
Site City, PA
Report #SAMPLE

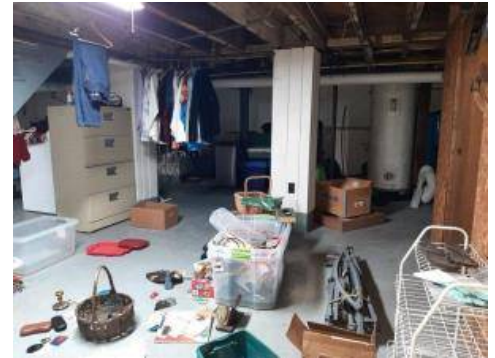
The basement area is dry and free of moisture. Maintaining moisture levels below 50% relative humidity is recommended to deter supporting members from advanced deterioration. Adding a dehumidifier will aid in controlling moisture levels.

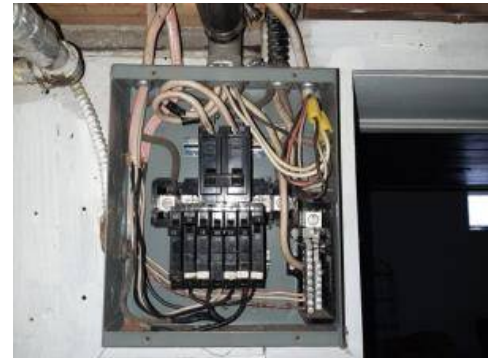
Location Sub Panel #3: Basement.

Note: Panel components are functioning as intended, however the panel is older and the overall performance and reliability is questionable. Consider upgrading the panel for added safety and increased value to the property.

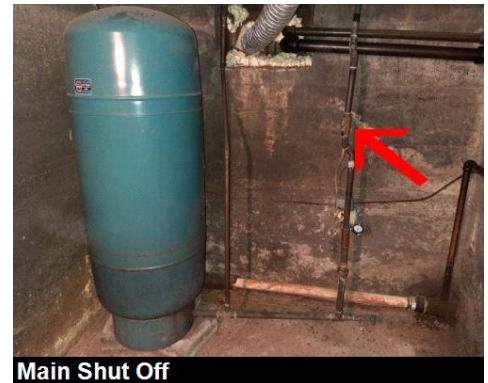
Main Shut Off

This equipment appears to be for supplying the garage.
 System was shut down at the time of the inspection.

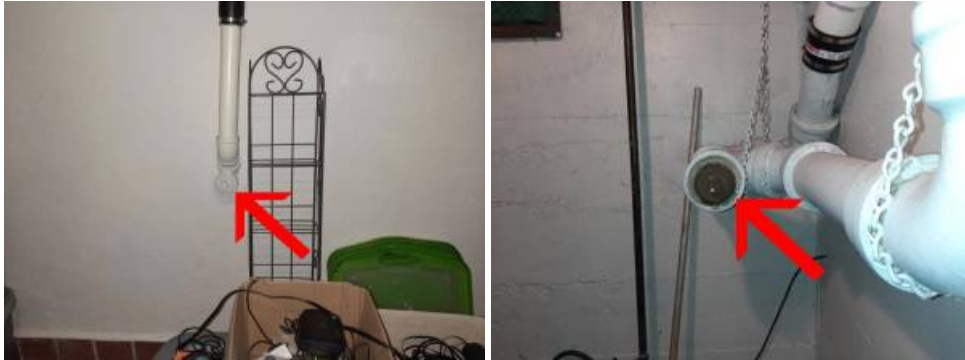
Older drainage lines installed. Although the system is functioning as intended and no leaks are found at this time where the lines are observable, the reliability of the system is diminished significantly due to the age of the system. Older systems are inherent to ongoing maintenance as issues arise and replacing the system may need to be considered in the extended future. S-trap is found in the drain lines under the sinks. S-traps have a tendency to siphon out the liquid seal in the trap when a basin of water is emptied. They are no longer used in new construction and should be eliminated where practical when renovations or plumbing repairs are under consideration. In the meantime, simply running a bit more water down the drain after a basin of water drains will act to restore the liquid seal in the trap in the event siphoning occurs.

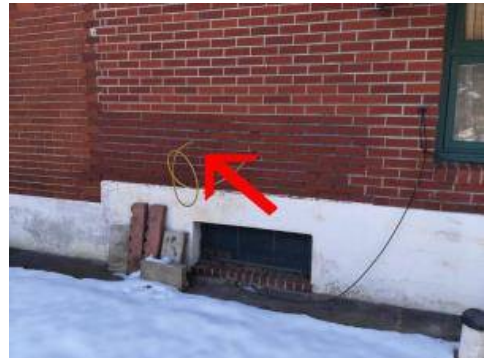
Limitations/Exclusions: Fuel tank was not located, asking the current owner as to the whereabouts of the fuel tank is suggested. The gas system was off, testing of any gas appliance could not be performed.

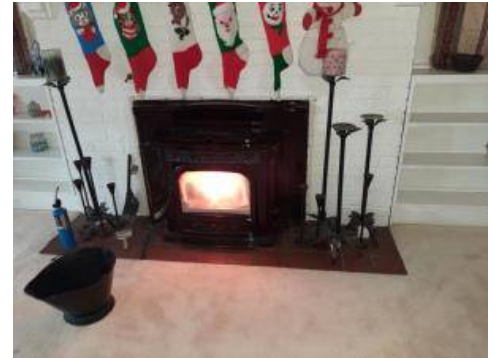
Location # 2: Living room.

The # 1 and # 2 stove is in satisfactory condition and functioning as intended. Masonry chimney has the stove pipe connected. A checkup of the stove by a qualified service technician should be performed bi-annually to ensure the stove is reliable and safe. Older masonry chimneys should have periodic inspections for structural integrity and cracks or other defects inside the flue, recommend that only a qualified chimney technician perform these inspections. In most cases special equipment is necessary for a thorough inspection of the flue and liner components.

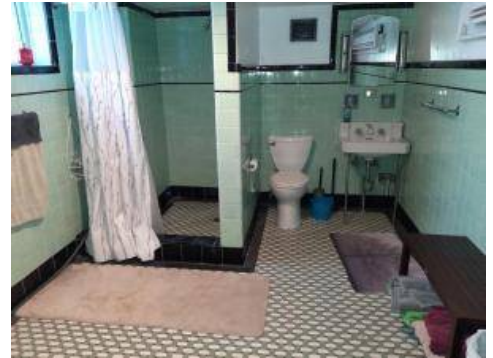
Location#5 : Basement bathroom. **Size:** 3/4 bath, there is a shower installed, no bath tub. **Sink Count:** 1.
Heating: Heat from central source.
Ventilation: No vent source installed.

- Observed in the # 5 bathroom(s): Drain line is leaking. A competent repair person with the proper skills can accomplish the needed remedies, corrections, or repairs.

- -
 -
 -
 -
- Observed in the # 5 bathroom: Vent fan is not installed. Window is inoperative. Recommend further evaluation with remedy as necessary by qualified, competent tradesperson.

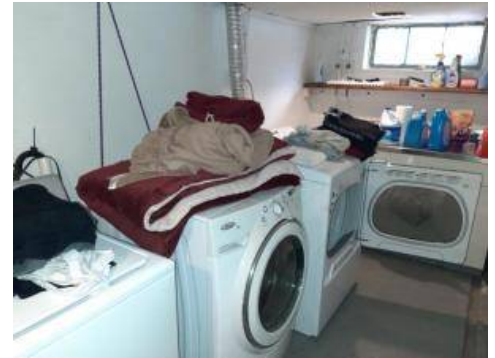
Location# 1 : Basement

Observed at the main house laundry room. Washer drain trap is not observed, suspect that an improper drain piping configuration installed. A competent repair person with the proper skills can accomplish the needed remedies, corrections, or repairs.

Observed at the main house laundry room. Dryer vent is not smooth wall pipe. Flexible piping installed for dryer vent pipe has the tendency to build up lint on the inside and may need more then normal cleaning on a periodic basis. Heavy build up of lint has the potential for being a fire hazard. Installing smooth wall metal piping is advised and keep any flexible pipe a maximum of 5 feet and installed directly behind the dryer. Dryer vent on the exterior of the home is installed near grade level. It's important to keep this area

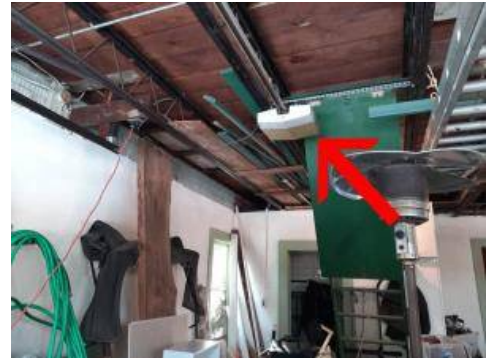
- -
 -
 -
 -
- Observed at the small garage door operator: Safety device does not appear to be installed for this door operator as it did not reverse with testing technique. Older garage door operators installed prior to the early 1990's did not have the requirement for an infrared safety beam at the base of the door frame. Although retrofit kits are available for older garage door operators, most homeowners desiring this safety device typically install a new operator because older operators may be nearing the end of their useful life. Lifespan of operators vary significantly depending upon use. With normal use of 4 cycles per day, most operators usually last about 10 to 12 years.

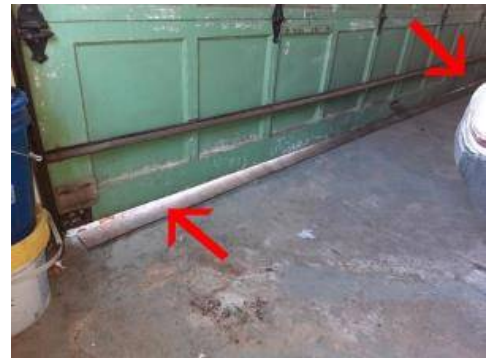
- -
 -
 -
 -
- Observed at the large garage door: Slab appears to be crowned as the door does not fully seal this area due to the slab not being level. Monitoring the situation is advised. Appropriate professionals should further evaluate if there are deficiencies suspected or confirmed in the future.
